PROPERTY INSPECTION REPORT

SAMPLE REPORT

James DAngelo
HomeTech Property Inspections

Any Street
Inspection Prepared For: Jones Bill

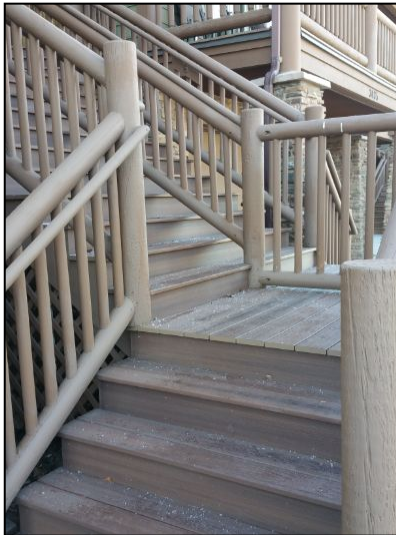
- Overall condition of the steps and stoops appears satisfactory
- Stain color is uneven on the stairs, typical maintenance is advised.

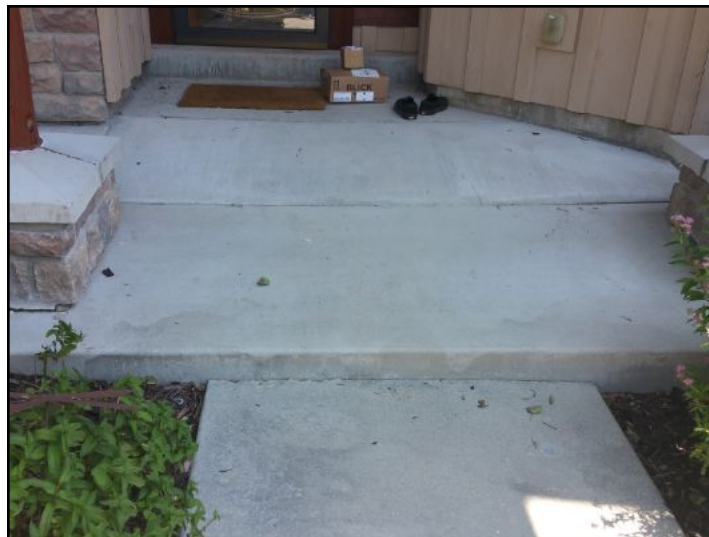
- Overall condition appears satisfactory.
- Surface raised/settled

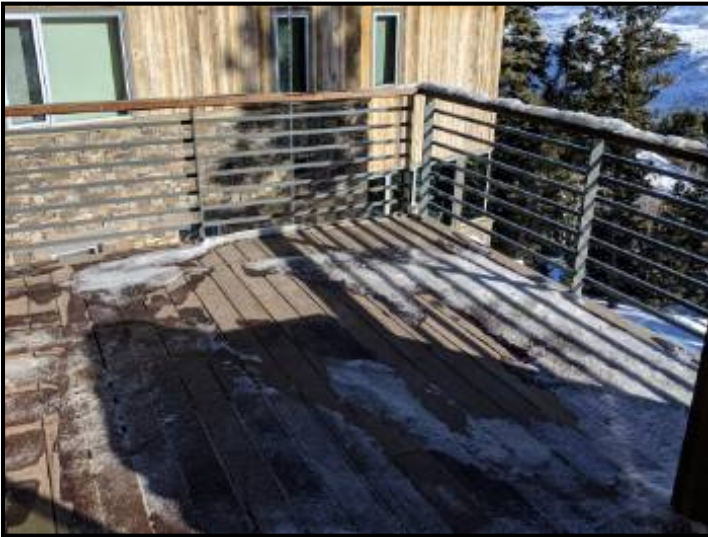
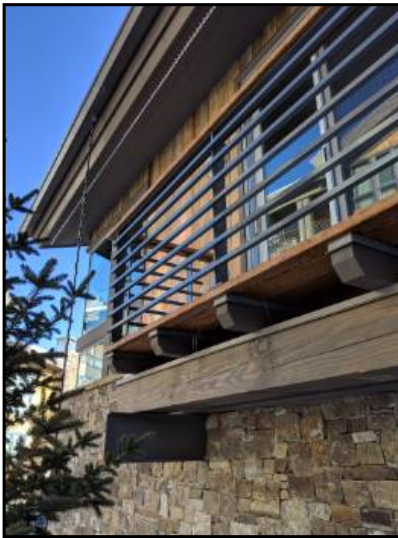
- Overall condition of the deck and rails appears to be in satisfactory condition overall.
- Support system appears to be in satisfactory condition.

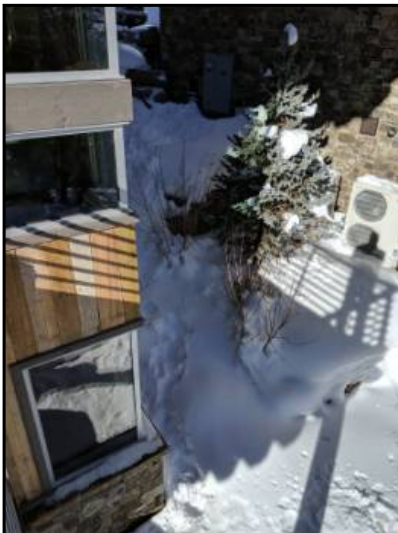
- Steep slope
- Snow covered- Unable to fully view. Overall drainage and grading should be reassessed when the snow melts.

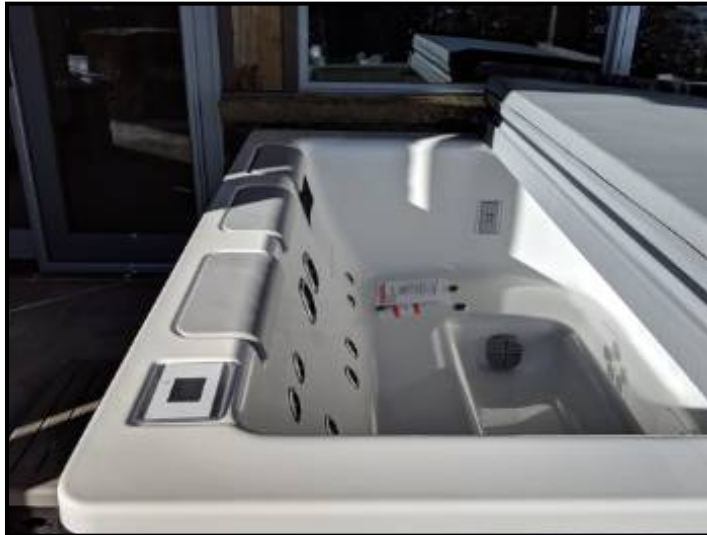
- this is a new hot tub it does not look like it has ever been filled yet. Function is not confirmed. No issues noted and there is a proper shut off located

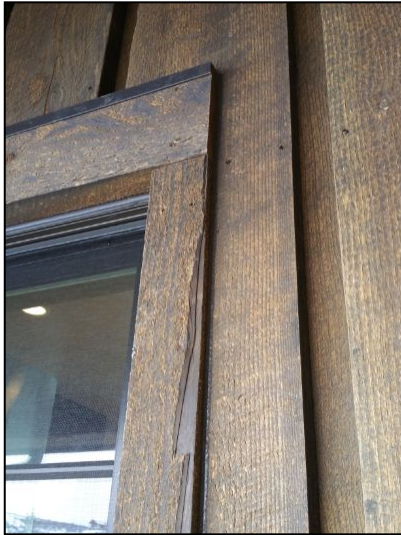
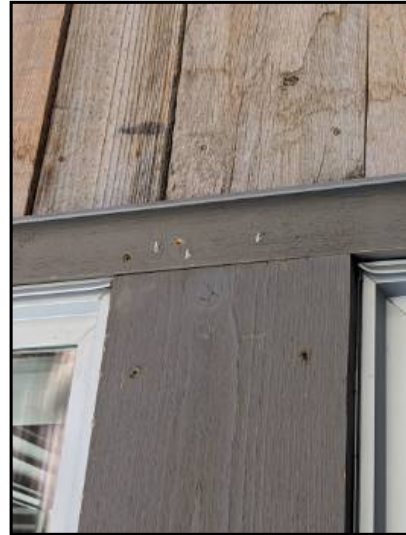
- Paint/finish/caulking advised. Pictured is an example, all areas should be checked and maintained as needed.

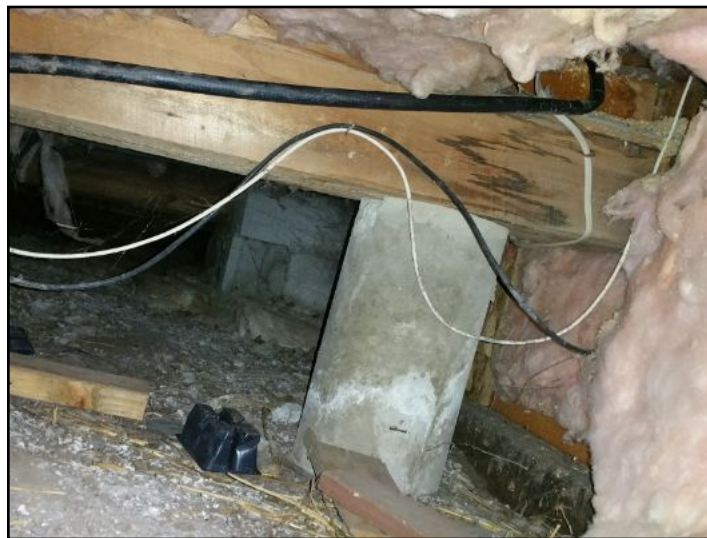
- **The main beam is in a condition that warrants further investigation or repair. Structural concerns noted. Further assessment advised by a licensed contractor and or engineer.**

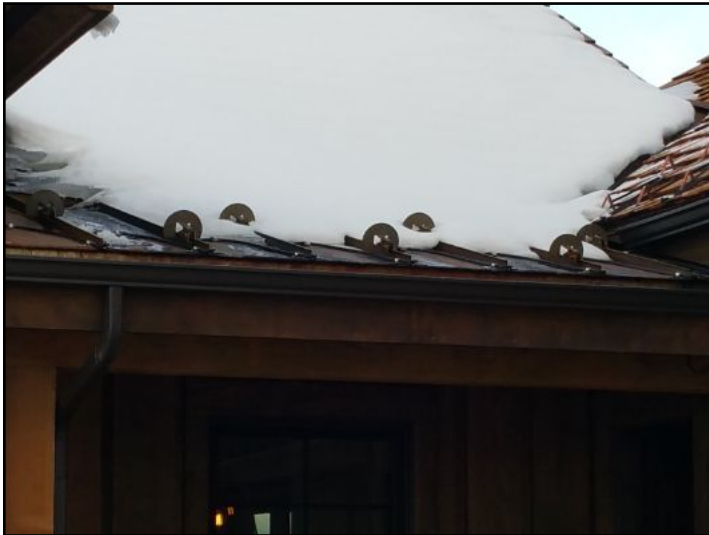
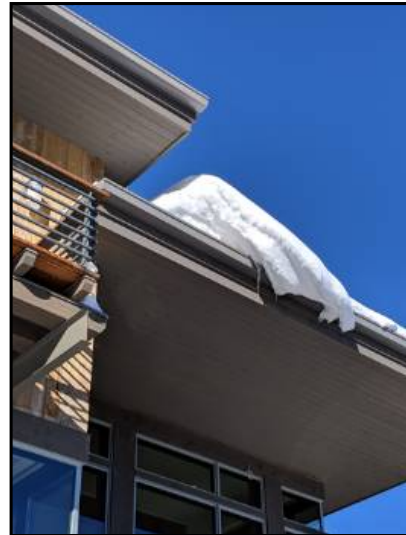
Materials: Gable • View was obstructed by snow, the condition of this roof cannot be commented on at this time. We recommend having it assessed or when snow melts.

monitor heavy snow loaded areas over time

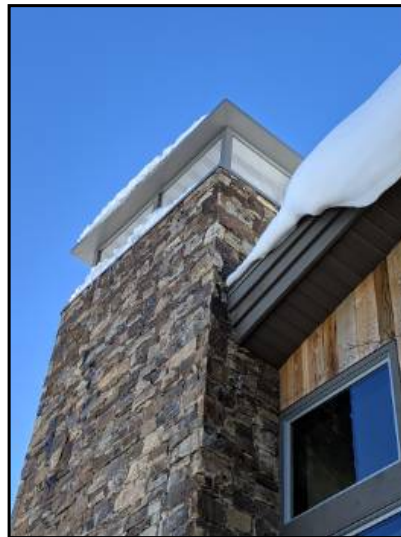
- Stone materials.
- Condition appears serviceable, no major concerns were noted from my vantage point.

not accessible due to snow cover in the roof area

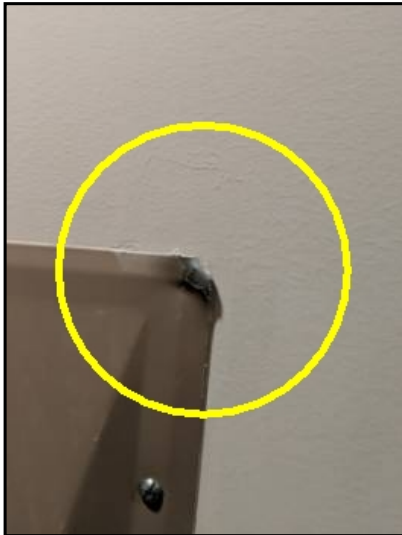
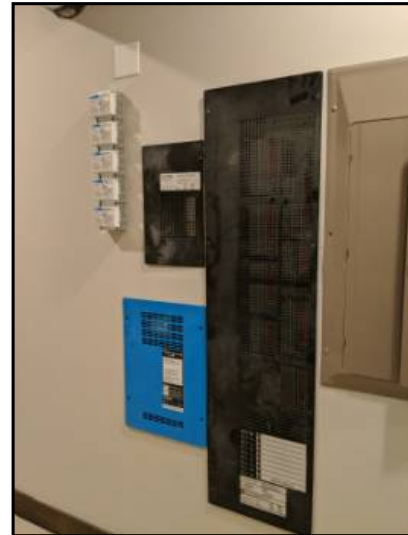
- Breakers and wiring appear to be in serviceable condition. The installation appears to be consistent with the standards at the time of construction.
- the panel is damaged on the corner. This does not affect function however it is not in New home condition

automated lighting system are not inspected in great detail. function of actual lights is tested in the interior section of the report

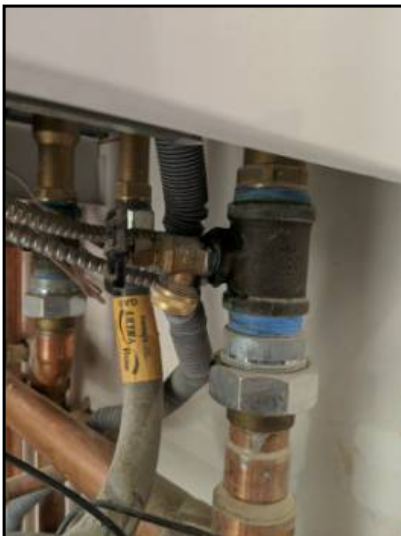
- Overall the boiler, valve and control system appear to be in serviceable condition. No major concerns were noted at the time of inspection, all zones appeared to be receiving heat flow.
- There are signs of slight leakage seen at one of the valves under the boiler. Further assessment and improvement is advised

Leak seen

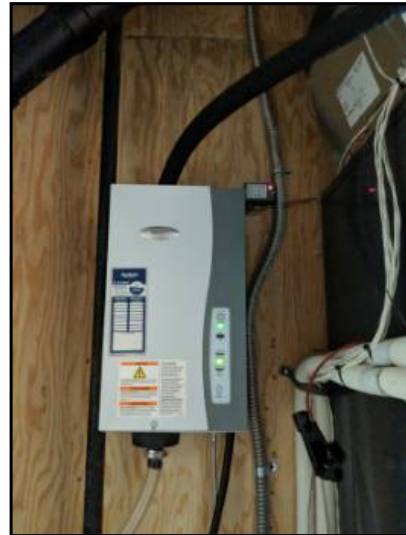
- Unit ran well on command using the thermostat, no major issues noted.
- Humidifier installed on the main level unit. We do not test these four full functional capability. It appeared to be on and no issues were indicated
- Unit is over 20 years old, you should have the heat exchanger checked and the current efficiency level determined by an HVAC contractor as a precaution.

humidifier installed on the main level unit.

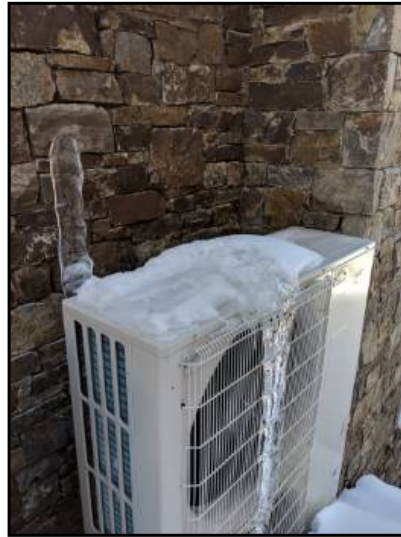
- Outside air temperature was below 65 degrees. Unable to test system at this time without risking damage to the condenser.
- the air conditioning condensers are positioned below a section of roof line. Water and ice is coming down and building up on these units. Improvements are advised to reduce the chance of damages

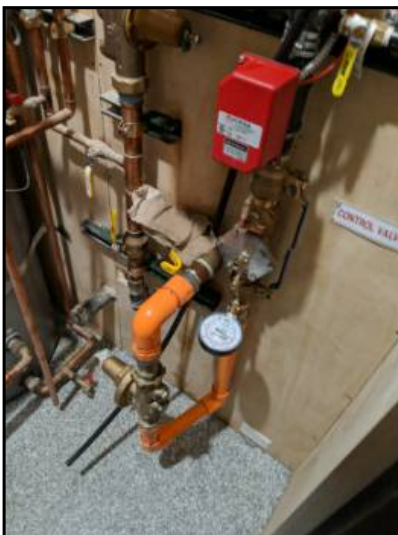
- There is not a current inspection tag. You should contact a fire system company to perform a full certified inspection of this system and tag it as inspected. You may ask the seller or builder if there is other documentation of inspection present. This was new construction however I believe this building in spend here for beyond a year
- Leaks seen at the riser, further investigation and improvement advised. Also there is an overflow line that leads to the floor the really should be a bucket for this to go into

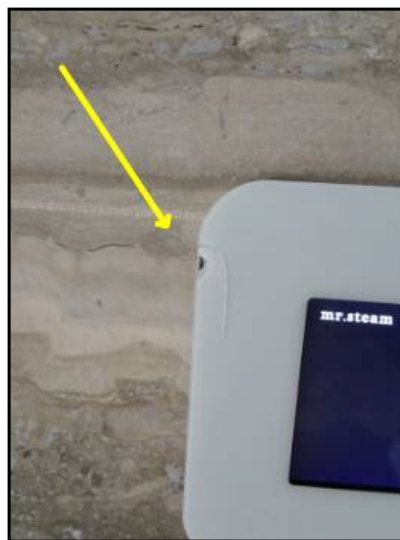
- There is a steam shower, it was functional using the normal controls. However the control panel is damaged. Further investigation and repair is advised by a licensed contractor. Master Bath

control panel in master bath

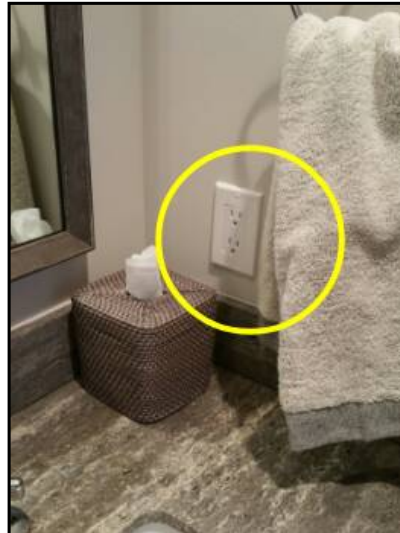
Hall Bath near kitchen

- No Ground Fault Circuit Interrupter (GFCI) protection of home electrical outlets was provided in the bathroom at the time of inspection. Although GFCI protection may not have been required at the time the home was built, for safety reasons, consider upgrading the bathroom electrical system to include GFCI protection.

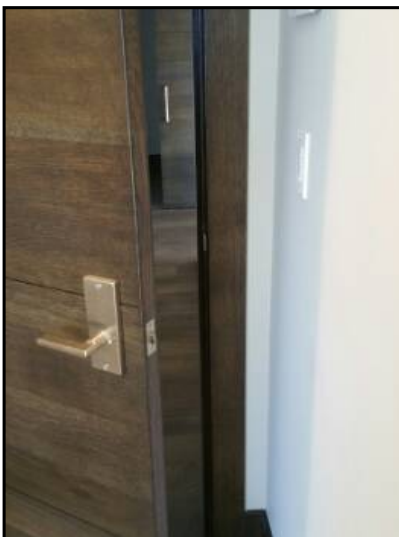
- The latch or strike plate needs to be adjusted so that the door will latch correctly. Master Bed,

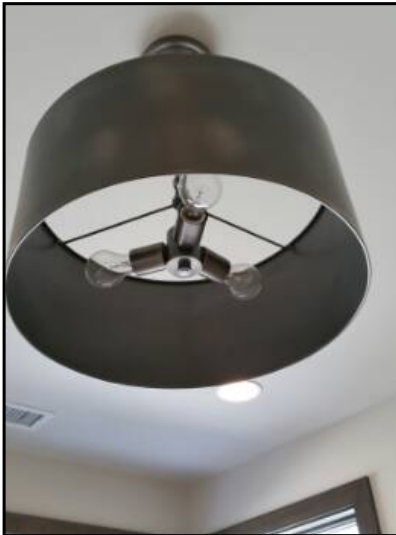
bedroom#5

- A light or part of a light installed in this room did not function using the wall switch. Change the bulb and reassess. Bedroom#5

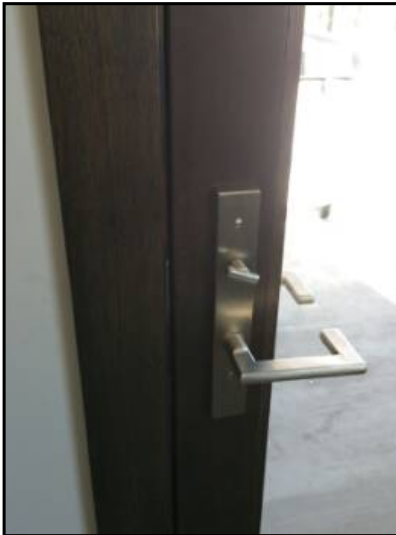
back door

- The Dead bolt needs to be adjusted so that the door will latch correctly. Rear Entry Area

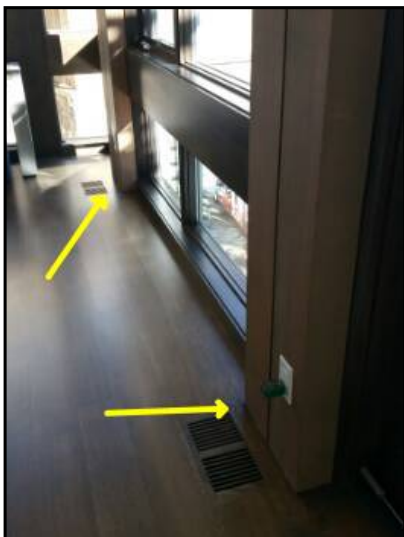
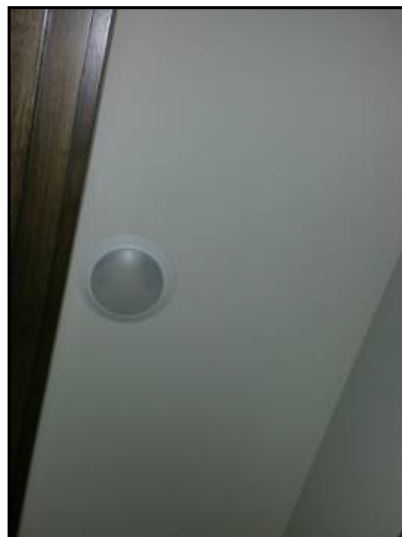
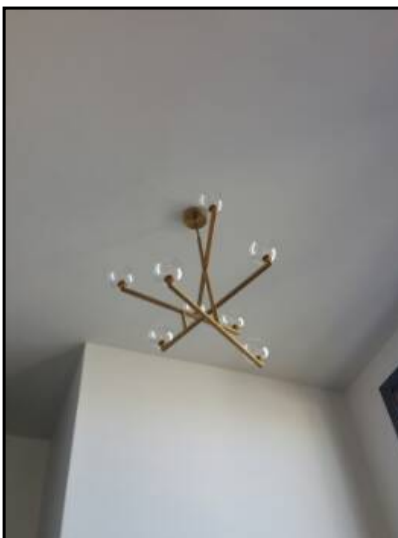
- A light or part of a light installed in this room did not function using the wall switch. Change the bulb and reassess. Entry Area
- Some grounded type outlets did not appear to be properly grounded. Living Room

living room

entry area closet

stairwell
